JAMES COOK CYCLONE STRUCTURAL TESTING STATION

## SIMULATED WIND TESTS ON A HOUSE

Part 2 — Results

G.N. Boughton\*

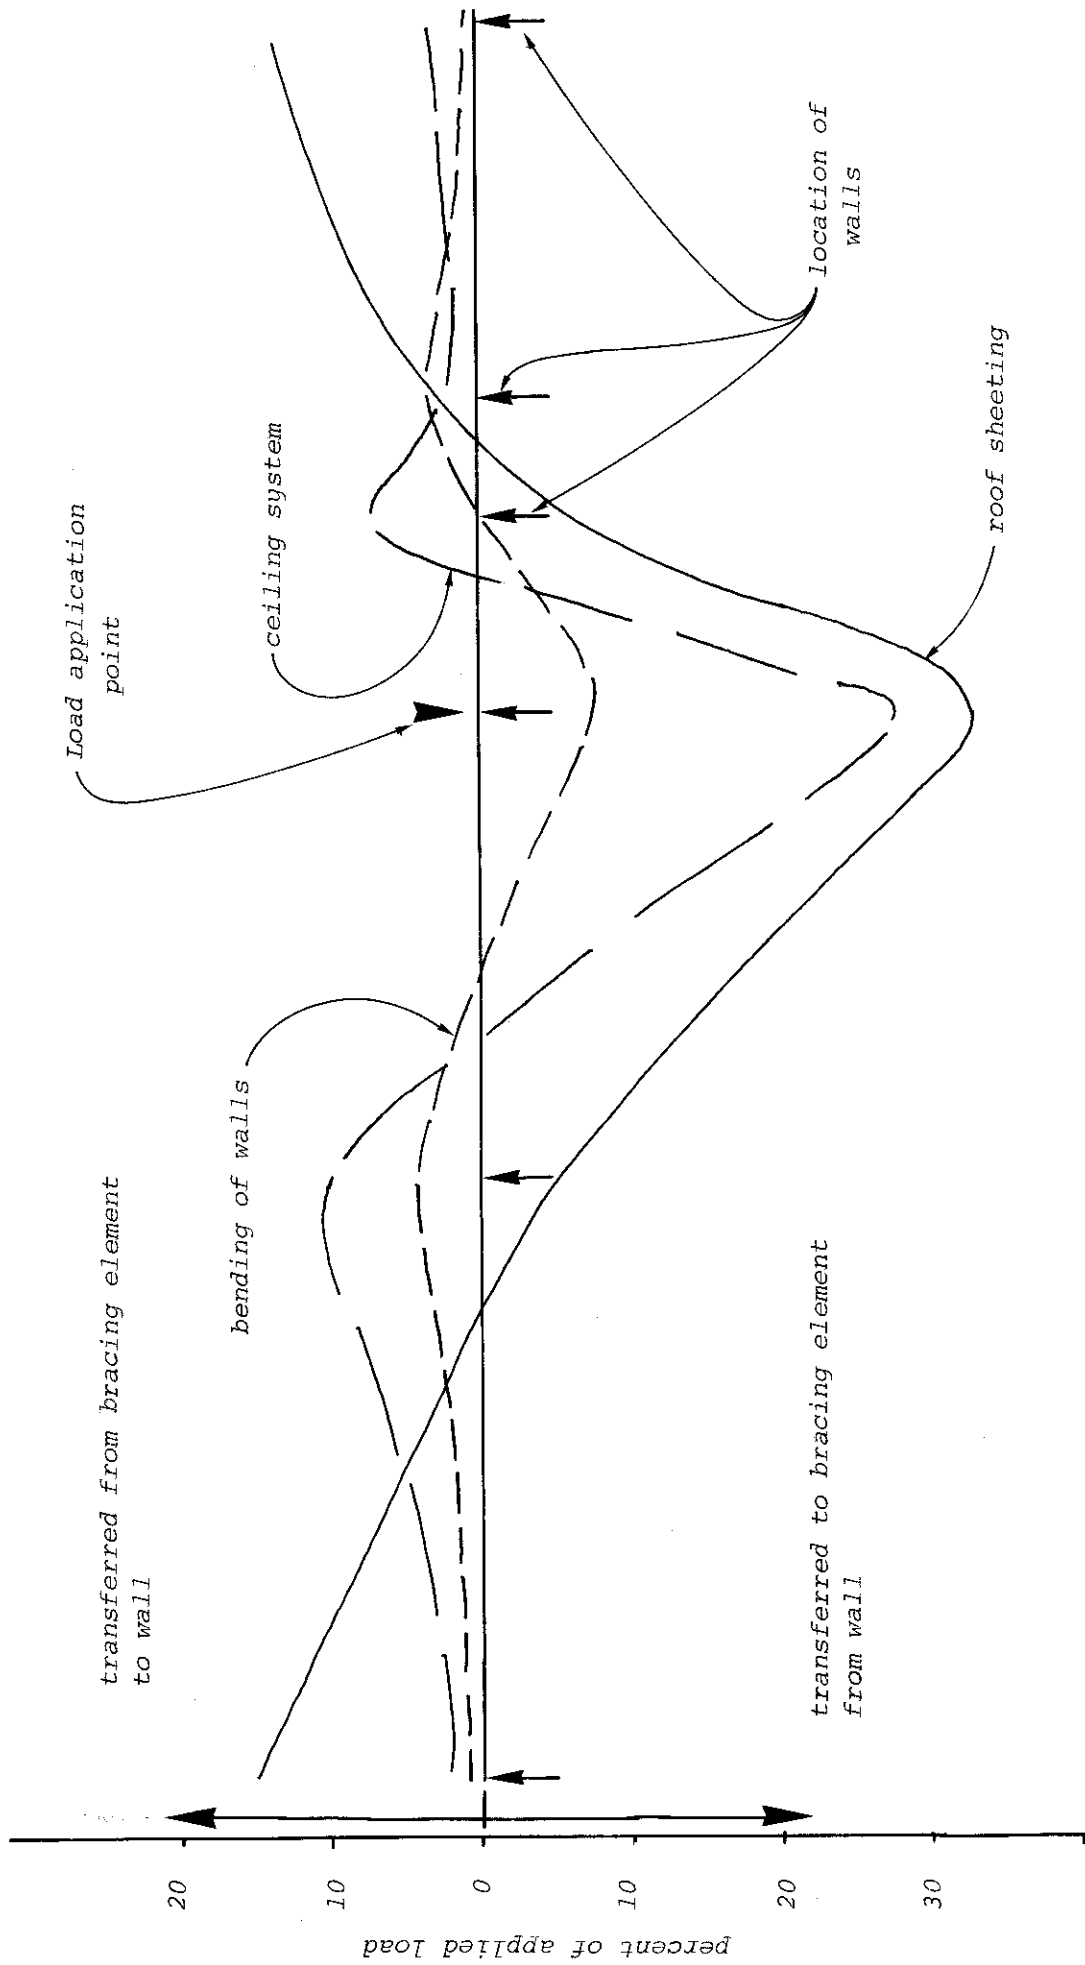
Figure 5. Percentage of applied load carried by lateral bracing elements.

that in the intact house 20% of the applied load was carried by the floor

The high percentage of load carried by the roof sheeting, and the large distances it can span make it a very useful lateral load carrying diaphragm.

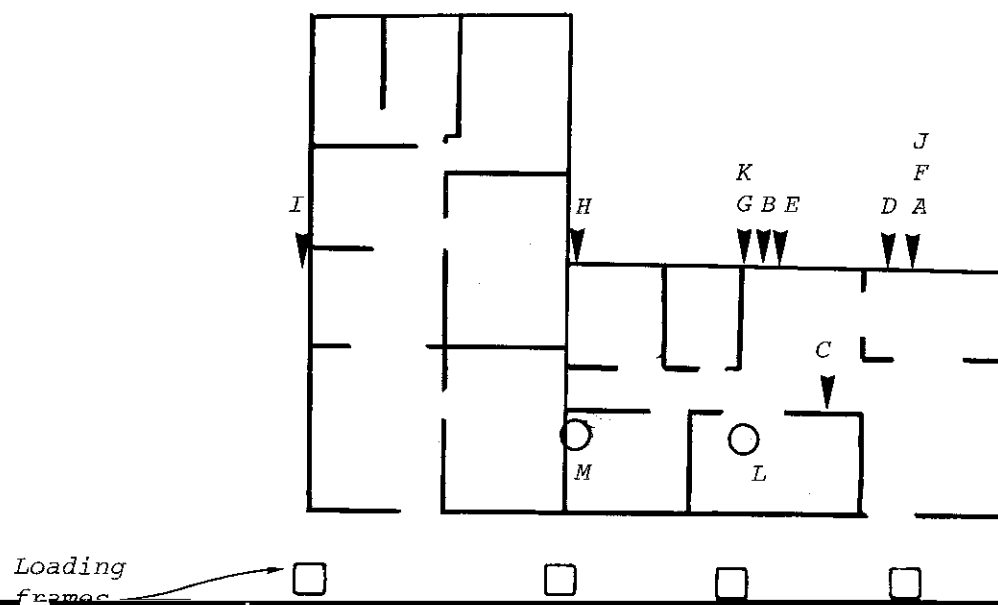
Figure A 1 Plan of house showing loading points

Points A to E stud loads  
 F to I top plate loads  
 J and K bottom plate loads  
 L and M uplift loads

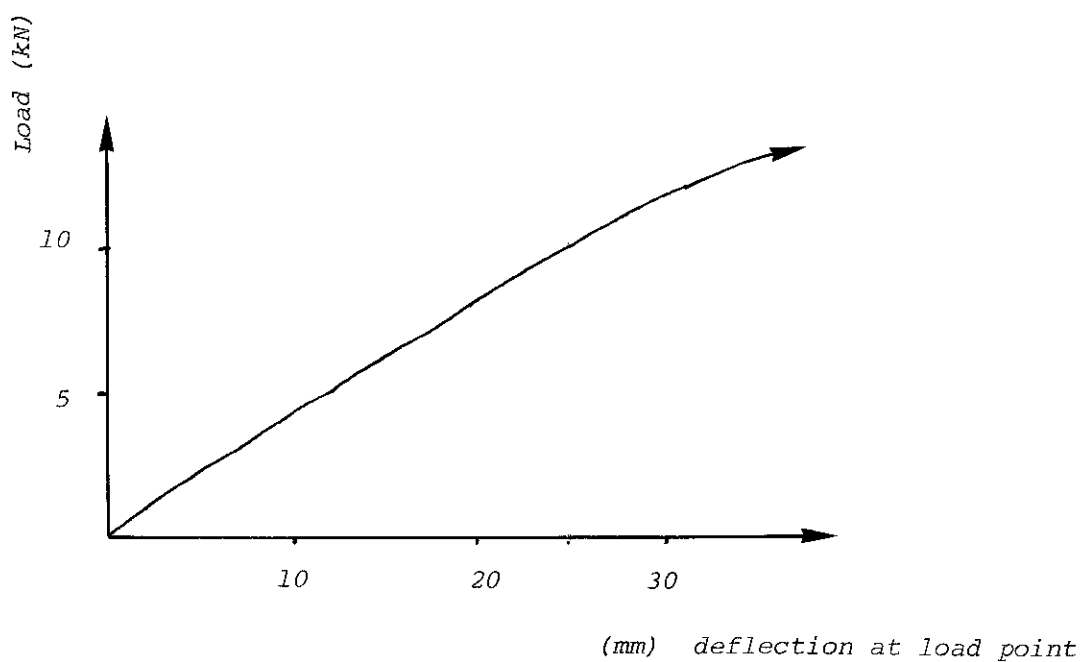
Figure A.5 Load-deflection curve for stud tests

The load was applied in 1 kN increments and deflections measured at all gauges for each increment up to 14 kN, then the gauges were removed for their protection as failure appeared imminent. Loading continued until
