The wind loading standard AS/NZS 1170.2 gives a strength limit state design wind speed of nearly 70 m/s referenced at 10 m height in open terrain, for the cyclonic regions of North Queensland. The damage investigation estimated the peak wind speeds to be less than this design value. This implies that structures designed to the wind loading standard should be structurally adequate for the wind forces generated during Cyclone Larry.

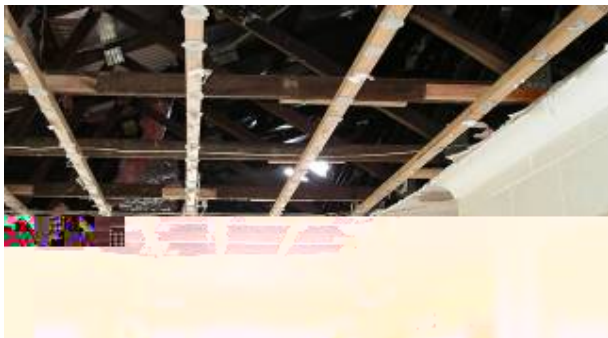
Housing constructed since the mid 1980s performed well, structurally. This is to be expected due to the contemporary housing having a regional design wind speed greater than the event wind speed. The main source of structural damage to newer construction was from wind driven debris. For a small number of cases, poor detailing led to loss of structural elements. In general, garage doors performed poorly leading to water ingress, internal pressurization and subsequent damage. The loss of flashings, guttering vents and soffits also contributed to water ingress, which on occasion resulted in the collapse of the ceiling. Such collapse could lead to structural problems if the ceiling is relied upon to provide diaphragm action to link bracing walls.
