CYCLONE TESTING STATION

Shoalwater and Roleystone WA tornadoes Wind damage to buildings

Report: TR54 August, 2008

TECHNICAL REPORT NO. 54

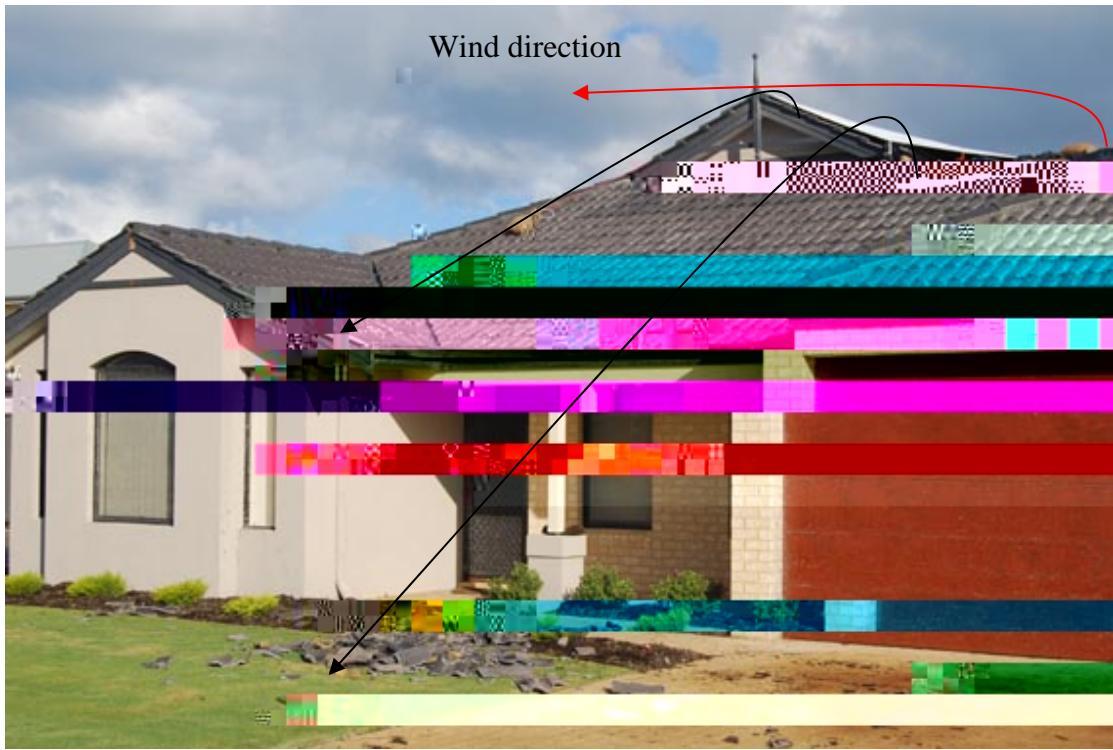
Figure 4.1 shows a roof with incidental tile damage in areas of the roof that would have experienced very high suctions under wind actions alone. In the affected area, there was no sign of debris impact and many of the tiles had been removed with little breakage. In some cases, the nail used to anchor the tile was still in place in the tile.

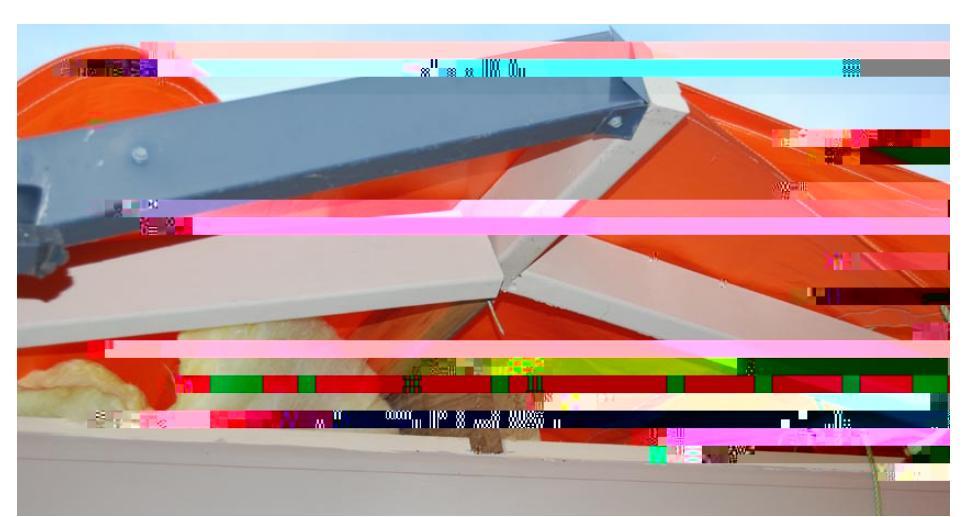
(a) failure of truss anchorage

In Figure 4.9, all of the trusses had lifted a little from the walls. For two trusses, the lifting had not been stopped, but in all of the others, once the slack had been taken out of the connection, the upward movement stopped in a few mm. Figure 4.9(a) shows one of the truss heels that had lifted.

The main cause of the loss of roofing was the two nail connection between battens and rafters. On this house a bugle head screw had been used for the edge batten to rafter connection. Many of these connections were adequate, but the rest of the roof used two nails and in some cases, loss of the rest of the battens had increased load on the bugle head screws to cause them to withdraw as well. Figure 4.9(b) shows the corner of the roof where all of the battens had lifted but the roof had not completely detached in this area.

For this house, the topographic class from AS4055 was higher than T1, and this should have been taken into account in the design of the house. Its wind classification was N3.

In considering the construction details used for this house, AS1684.2 [5] Table 9.14 showed that the required batten to rafter force was 2.3 kN within 1200 mm of the edge of the roof and 1.2 kN in the remainder of the roof. AS1684.2 [5] Table 9.25 shows that two nails have a capacity of 0.64 kN, and one bugle head screw has 4.5 kN.

Thus in this roof, the edge batten had excess capacity 4.5 kN to meet an uplift demand of 2.3 kN, but the next batten in from the edge (also within the edge zone), had a connection capacity of only 0.64 kN to m

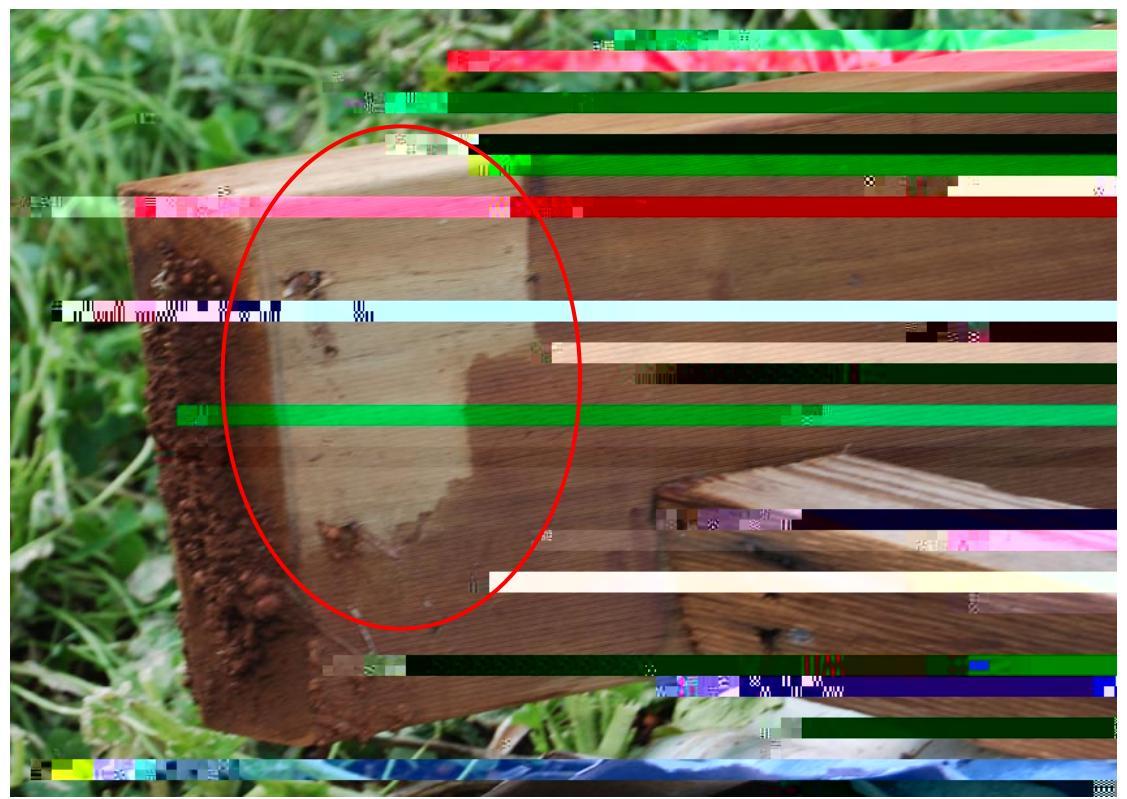
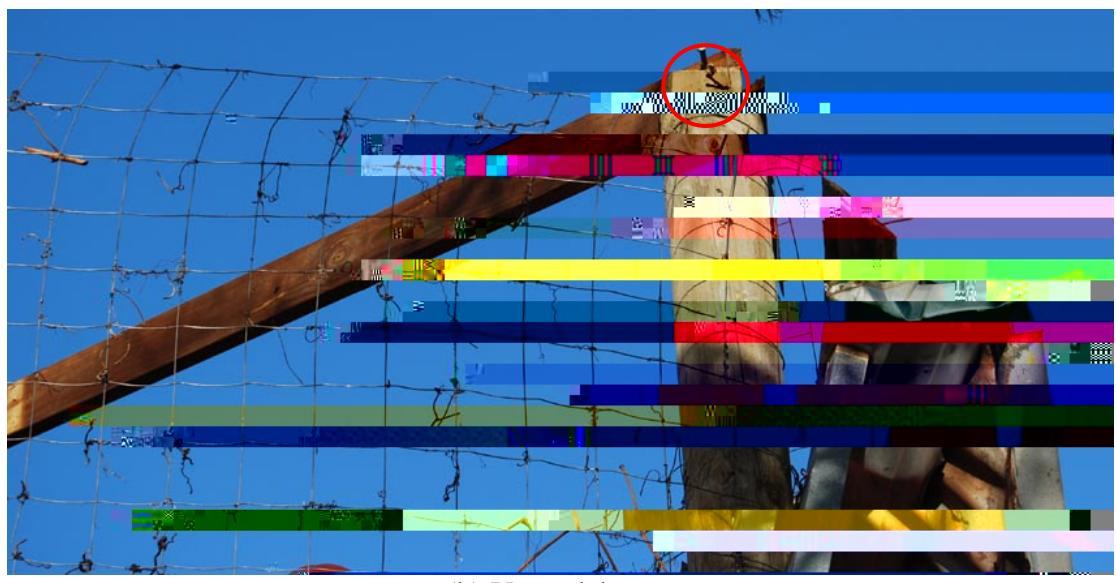
Figure 5.2 shows a verandah beam to post connection that failed under wind load leading to loss of both the verandah and main roofs. This connection was made with two nails, but two M16 bolts are specified in AS1684.2 [5].

Figure 5.2 Verandah beam to post connection

The information required to correctly select and apply this detail is outlined in AS1684.2 [5]:

- The wind classification of the house is found from AS4055 [2].
- Table 9.13 in AS1684.2 [5] can be used to select a force from the roof type, wind classification, roof load width, and spacing between beam to post connections.
- Table 9.20 in AS1684.2 [5] can be used to select appropriate connections to resist wind uplift forces.
